Manhole Inspection Summary

Manhole # S17SS1001MH

Insp Date: **5/25/07 12:51 PM**

Location Address: **CYLBURN AVE**

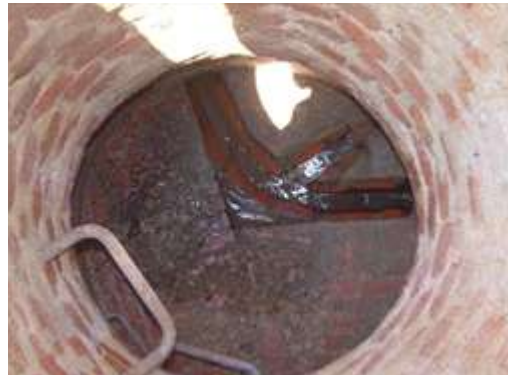
Top View

Evidence of surcharge - Bench debris.

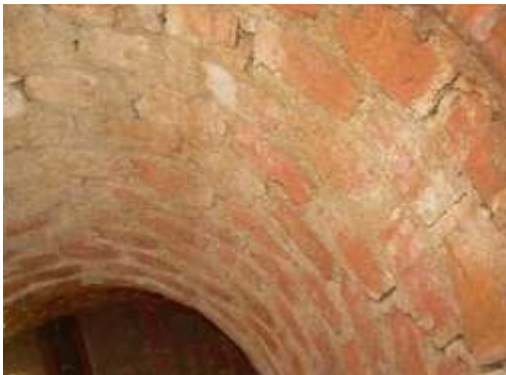
Defect

Condition: ☐ Sound ☐ Cracked ☐ Root Intrusion ☐ Loose Brick ☒ **Deteriorated**

Infiltration: ☐ None ☒ **Joint** ☐ Cracks ☒ **Mortar** ☐ Roots ☐ Wall

Infiltration: ☐ None ☐ Joint ☐ Cracks ☒ **Mortar** ☐ Roots ☒ **Wall**

Adjustment deterioration and infiltration.
Corbel infiltration.

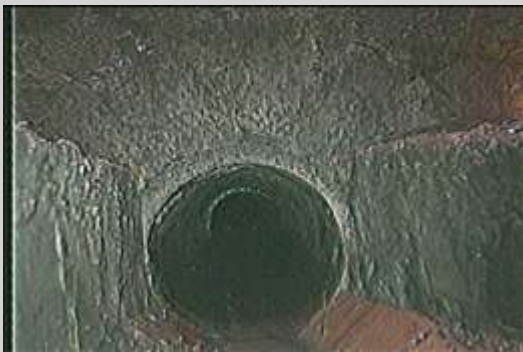
6 in. Circular Gravity Sewer Pipe Out @ 12 O'Clock

Invert Depth: **7.97** (ft.) Flow Characteristics: **Slow**

Infiltration: **None** Pipe Seal Cond: **Unknown**

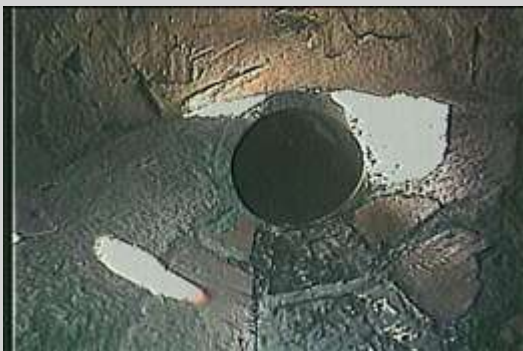
4 in. Circular Gravity Sewer Pipe In @ 2 O'Clock

Invert Depth: **7.44** (ft.) Flow Characteristics: **None**

Infiltration: **None** Pipe Seal Cond: **Unknown**

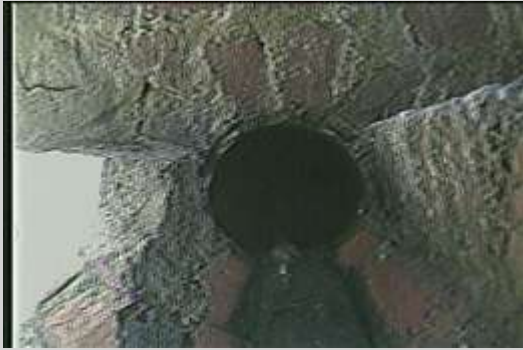
6 in. Circular Gravity Sewer

Deposits: ☐ None ☒ **Mud** ☐ Sludge ☒ **Debris** ☐ Grease

Silt Depth: **0.5** (in.)

Deposits Extent: **Light**

Infiltration: **Evidence**

Pipe Seal Cond: **Cracked**
